LPC1549 Xpresso v2 Rev B board Silkscreen errors; Apr 30, 2014

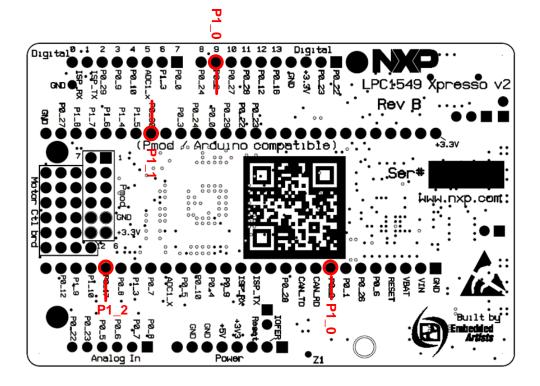
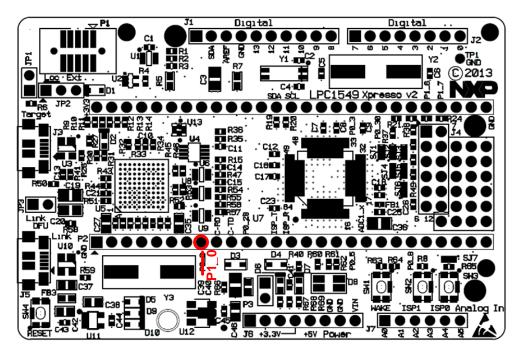
Several errors in the top and bottom side silkscreen incorrectly identify the LPC1549 port pin associated with the header pin. The correct port references are shown (in red) in the diagrams below. The schematic "LPC1549_LPCXpresso v2_schem_Rev_B2.pdf" posted on LPCWare.com is correct. The table below also shows which header or receptacle pins have mis-labeled silkscreen (column 2) and the corresponding correction (column 3).

LPCXpresso1549 Rev B board	Column1	Column2	Column3
Xpresso header	Pin #	incorrect silk	correct silk
P2	8	P0_2	P1_0
P2	23	P0_17	P1_2
P2	47	P0_30	P1_1
Aruduino Rect	Pin #	incorrect silk	correct silk
J1	Digital 9	P0_2	P1_0
